805-256-5519
CHRIS LOWE

INSPECTION REPORT

From the inspection on:

August XX, 2011

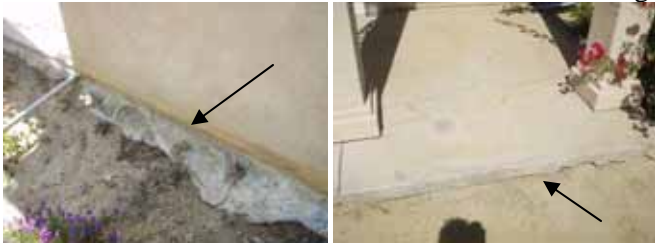
- 1-2 **EROSION:** There has been some likely erosion (back left of the house) where exterior site drainage should be corrected (left side of the house) (back left patio) – correction is needed – this support and soil needs to be corrected – there was no foundation damage visible at this time

(e.g., control drainage, return soil where missing)

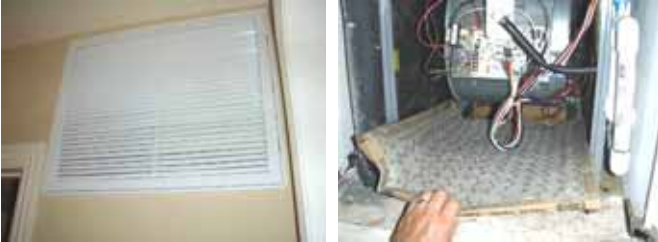
- 8-1 **FILTER DIRTY:** The furnace filter is dirty – it needs changing. It is advisable that you change the filter (e.g., after every 3 months of normal heater/AC use). Your local hardware store typically sells replacement filters
