805-256-5519
CHRIS LOWE

INSPECTION REPORT

August XX, 2011

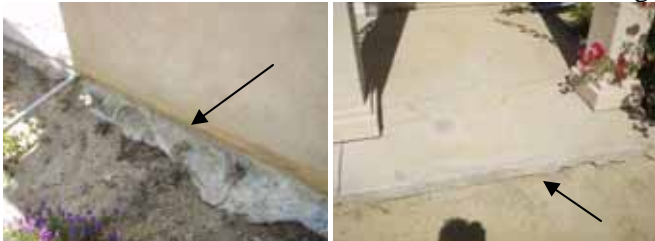
- 1 - 2 EROSION: There has been some likely erosion (back left of the house) where exterior site drainage should be corrected (left side of the house) (back left patio) – correction is needed – this support and soil needs to be corrected – there was no foundation damage visible at this time

(e.g., control drainage, return soil where missing)

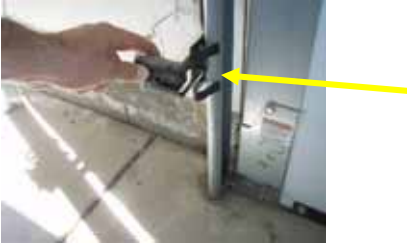
- 10-2 **TOO HIGH:** The garage door opener's electric "eye" is too high above the garage floor (it is 8 inches high and it is supposed to be 6 inches above the floor). We recommend correction
